# MAX32672 ERRATA SHEET

## Revision B2 Errata

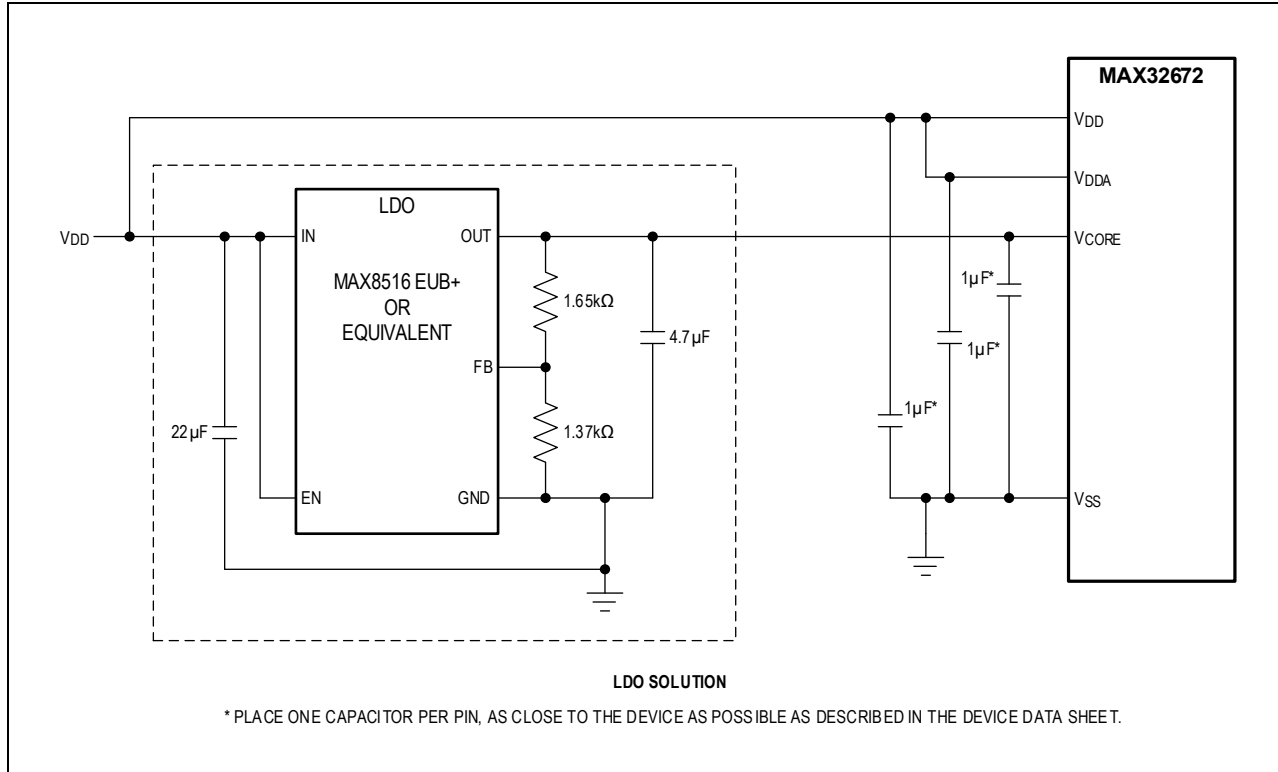
Figure 1. MAX32672 LDO Solution with MAX8516

### 2) MEMORY MAY BE CORRUPTED DURING POWER-DOWN WHEN OPERATING IN DUAL-SUPPLY MODE

Incorrect sequencing of the  $V_{DD}$  ( $V_{DDA} = V_{DD}$ ) and  $V_{CORE}$  supplies can corrupt the flash memory contents.

- Control the power supplies so that:
  - $V_{CORE} \geq V_{CORE(MIN)}$  before  $V_{DD} > V_{RST(VDDMIN)}$  on power up
  - $V_{DD} < V_{RST(VDDMIN)}$  before  $V_{CORE} \leq V_{CORE(MIN)}$  on power down
- RSTN is asserted active whenever  $V_{CORE} \leq V_{CORE(MIN)}$ .

Workaround #1 can be implemented using an LDO such as the MAX8516 or equivalent, as shown in [Figure 1](#). The LDO is guaranteed to regulate its output, which drives  $V_{CORE}$  well below  $V_{RST(VDDMIN)}$ .
